27 July 2017

## **Possible Safety Issues – Sermac Concrete Placing Unit Booms and Periodic Inspections**

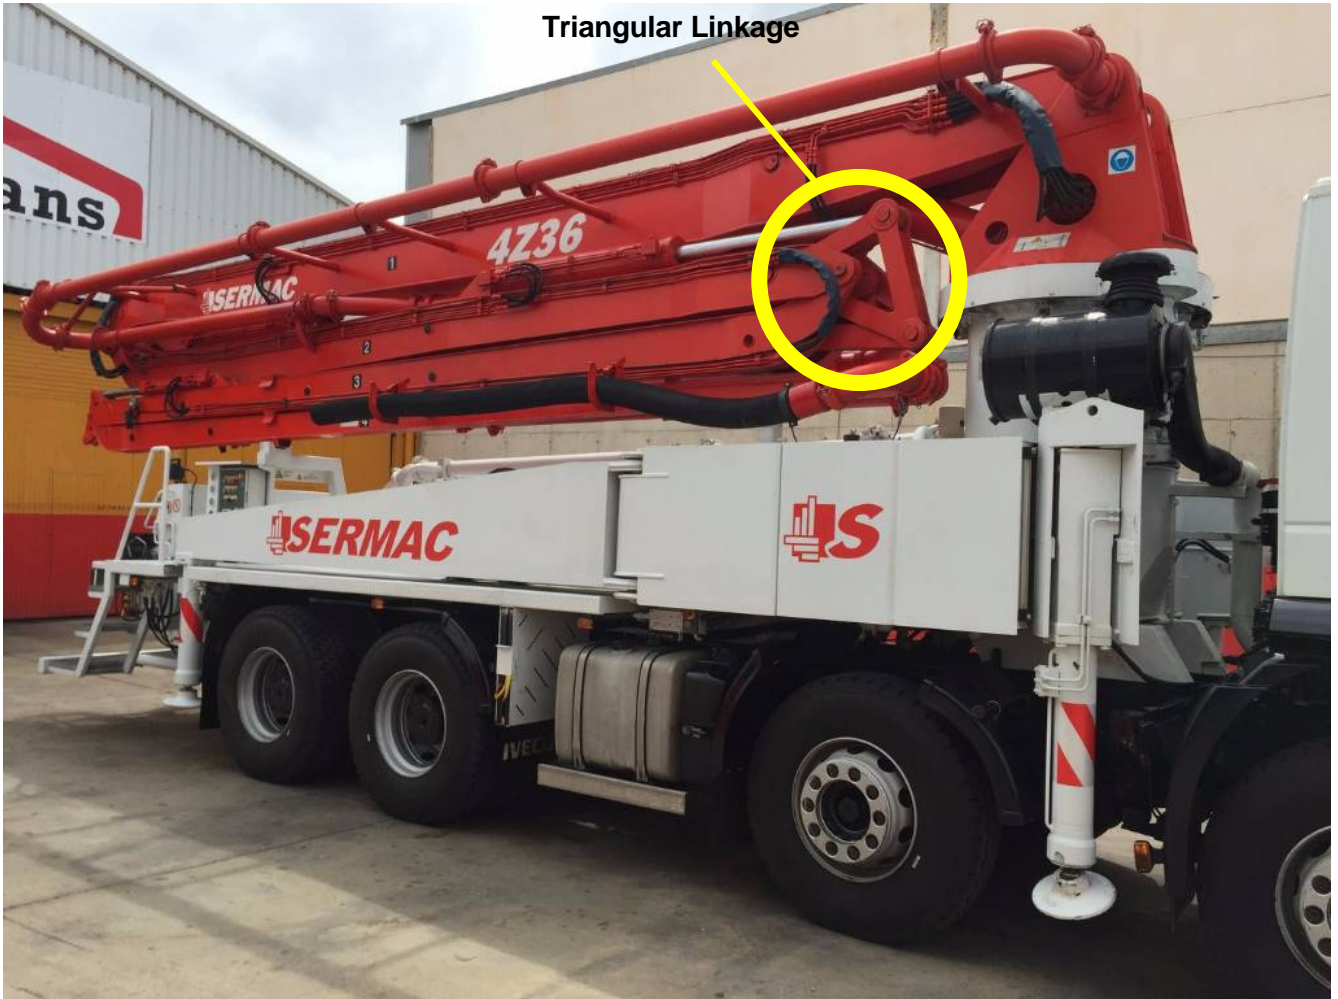
Photograph 1

An incident occurred in Melbourne in 2015 involving the failure of a Sermac Model Z 41 concrete placing unit's boom. A boom linkage failed that resulted in the boom's collapse. Assessment of the failed linkage by an independent consultant engaged by the owner identified inadequate weld penetration of an external weld that may have contributed to the failure.

The triangular linkages are located at some joints between boom sections, as depicted in the Photograph 1.

A similar incident occurred in 2012 involving the failure of a boom triangular linkage component on a Sermac concrete placing unit. Welds on the component were identified to have failed, allowing the boom section to partially collapse.

- insufficient penetration of external welds, and
- incorrect or missing internal welds in comparison to the manufacturer's design drawings.

Furthermore, the closed box construction of the triangular linkage means that the internal welds were not readily accessible for inspection. Disassembly of the boom section to access the triangular linkages (including creation of an inspection opening, as specified, verified and made by a suitably

Triangular Linkage

Accordingly, WorkSafe recommends that operators of Sermac units contact their supplier for further advice, or engage a suitably competent person experienced in crane and concrete placing unit inspections to examine their unit's boom components in accordance with inspection criteria listed in the Australian Standard, including non-destructive inspection of all welds on the boom triangular linkages.
